BRIDGE NO. 90/25N
HOMER HADLEY FLOATING BRIDGE
INSPECTION SUMMARY TABLE (CABLES)
(Continued)

UNDERWATER INSPECTION REPORT - FLOATING BRIDGES

Homer Hadley Floating Bridge

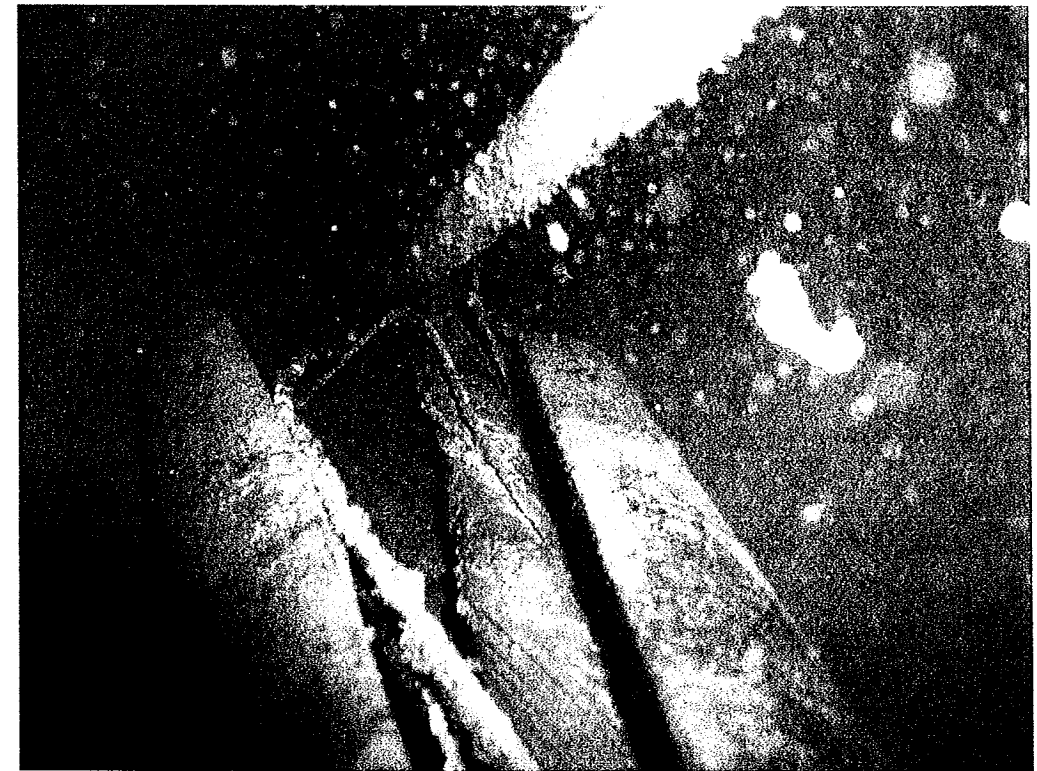
PHOTOGRAPH NO. 3: Cable Asw. View of open protective sleeve and broken cable wires within pontoon port.

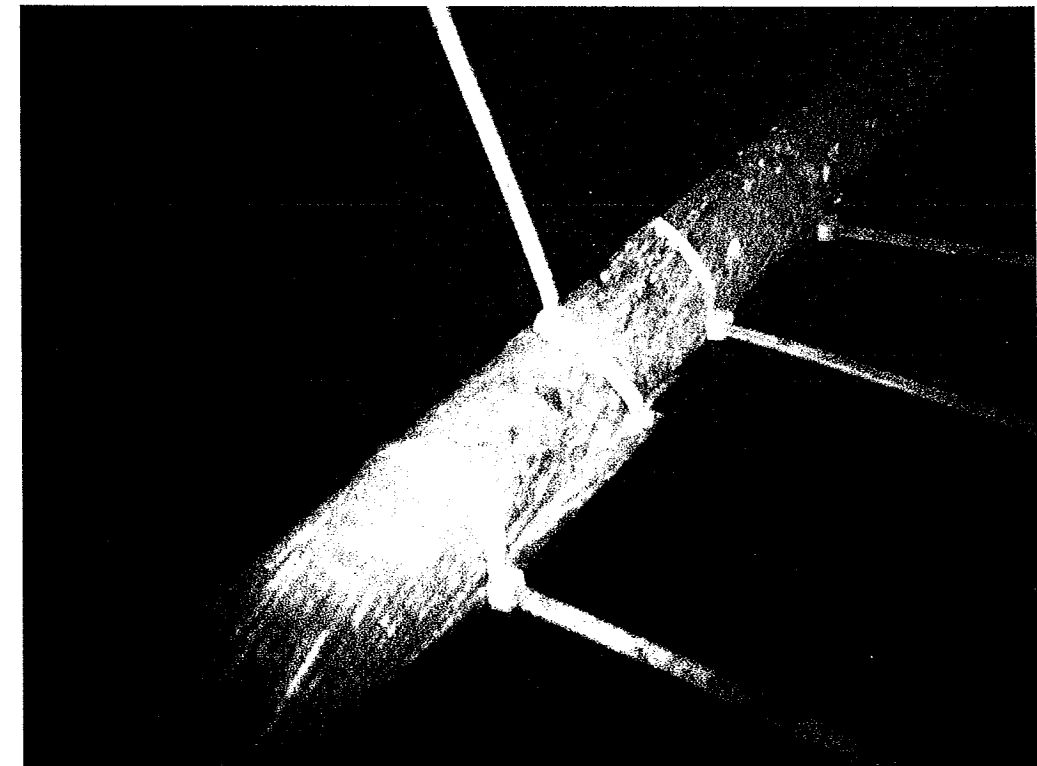
PHOTOGRAPH NO. 4: Cable Bn. View of previous seizing repair located approximately 15 feet south of buoy clamp.

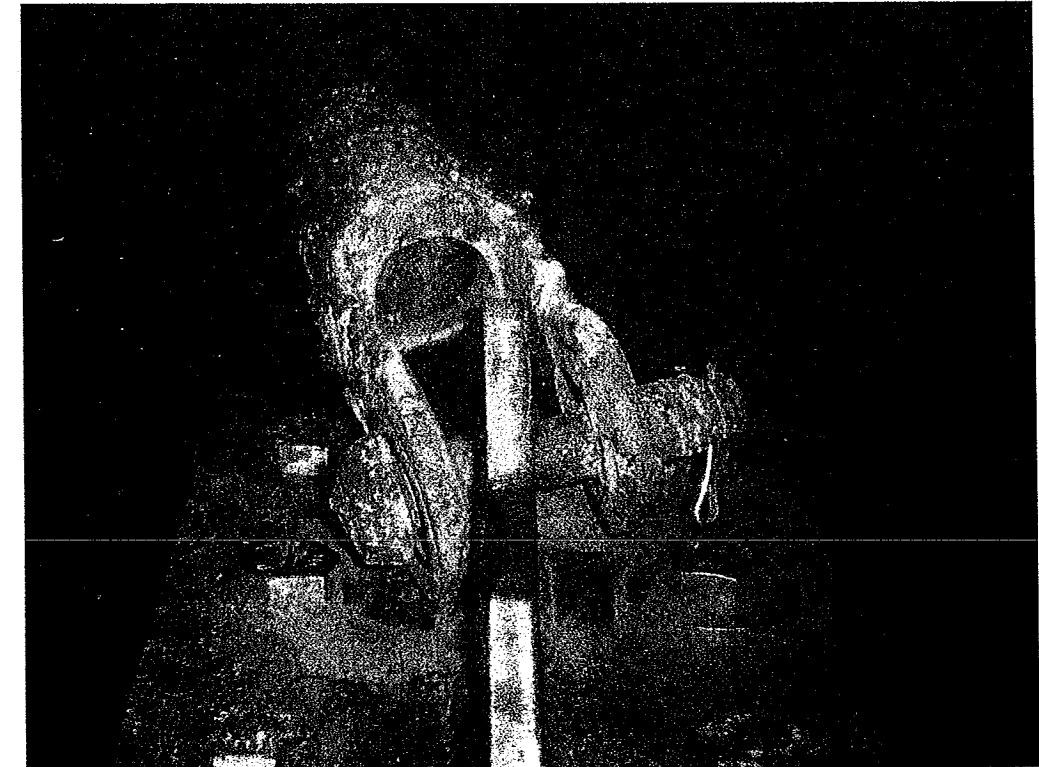
PHOTOGRAPH NO. 5: Cable C_N. Typical view of the buoy clamp clevis pin with 50% loss of section due to wear.

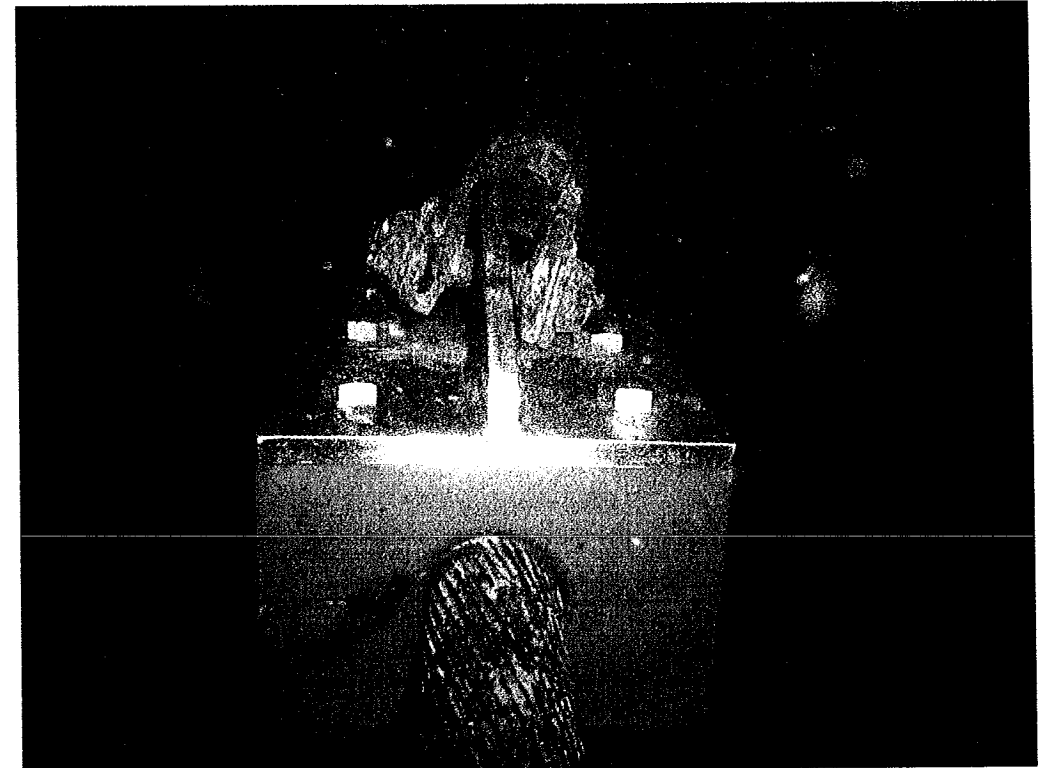
PHOTOGRAPH NO. 7: Cable D_N. Typical view of the buoy clamp and buoy clamp clevis pin with 30% to 35% loss of section due to wear.

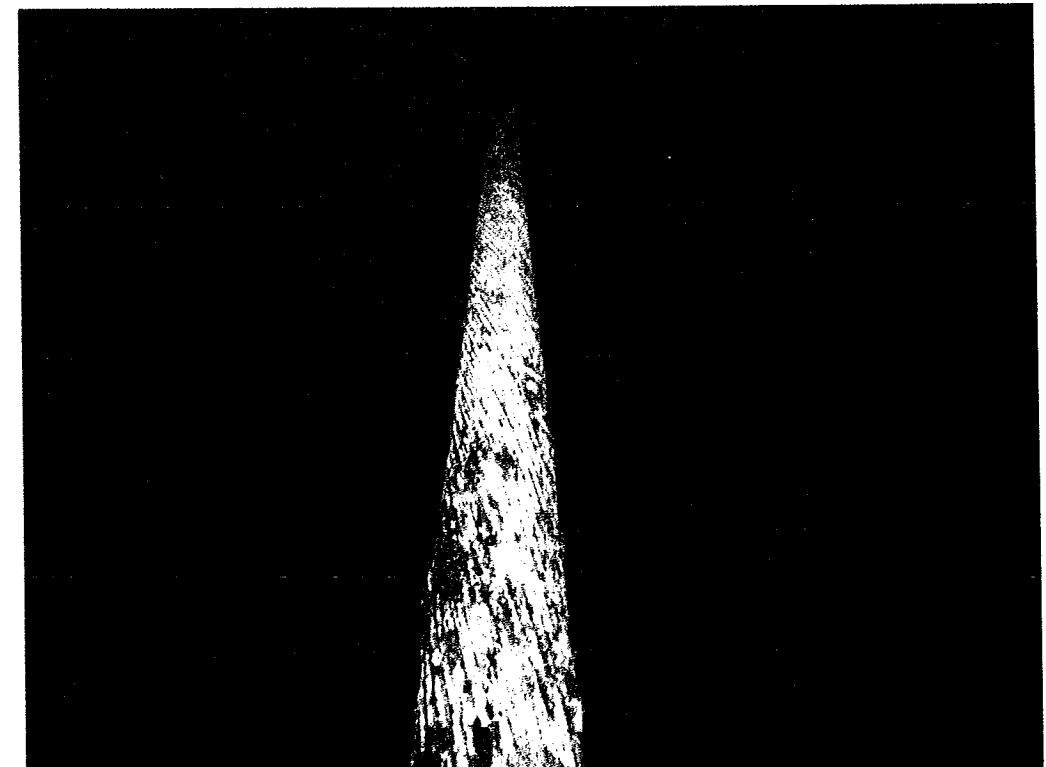
PHOTOGRAPH NO. 8: Cable E_N. Typical view of light to moderate corrosion from -3 feet to -10 feet.

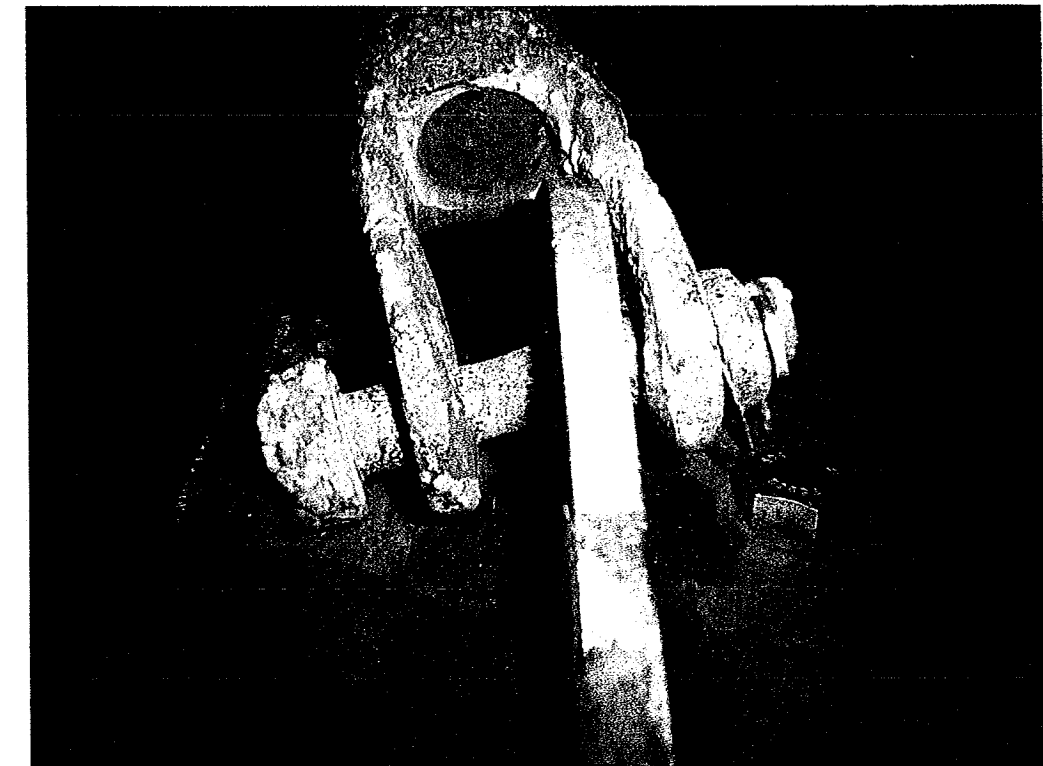
PHOTOGRAPH NO. 10: Cable H_N. Typical view of the buoy clamp clevis pin with 10% to 15% section loss due to wear.

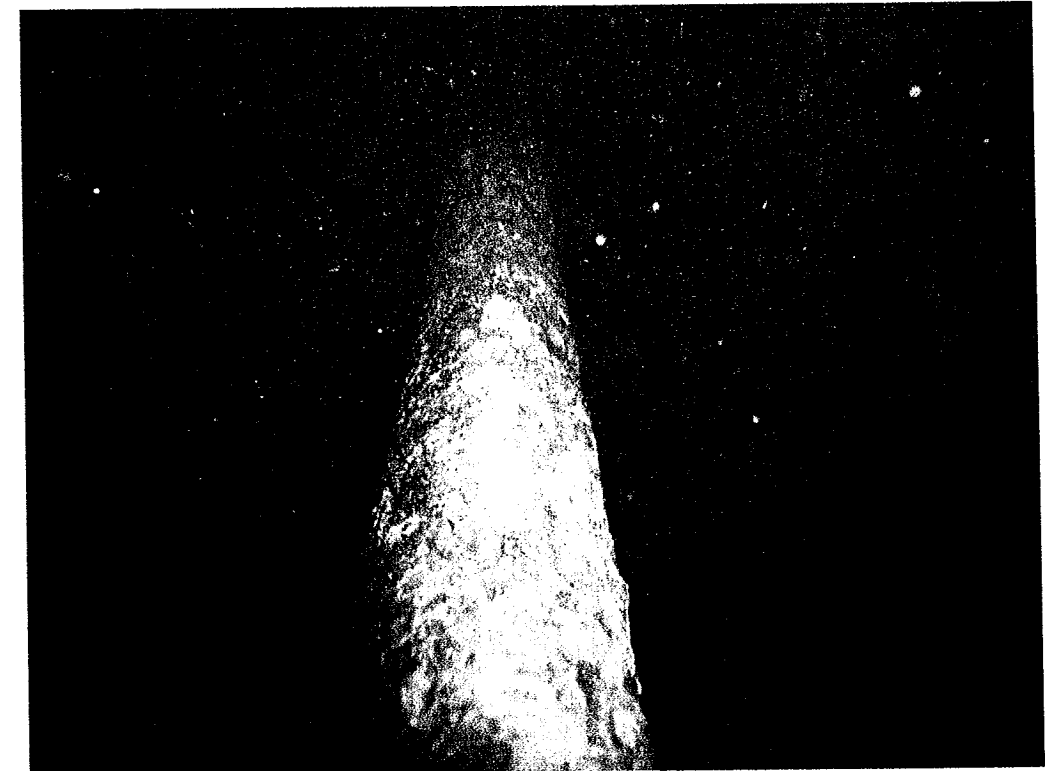
PHOTOGRAPH NO. 13: Cable JN. Typical view of moderate corrosion from the pontoon port to -3 feet.

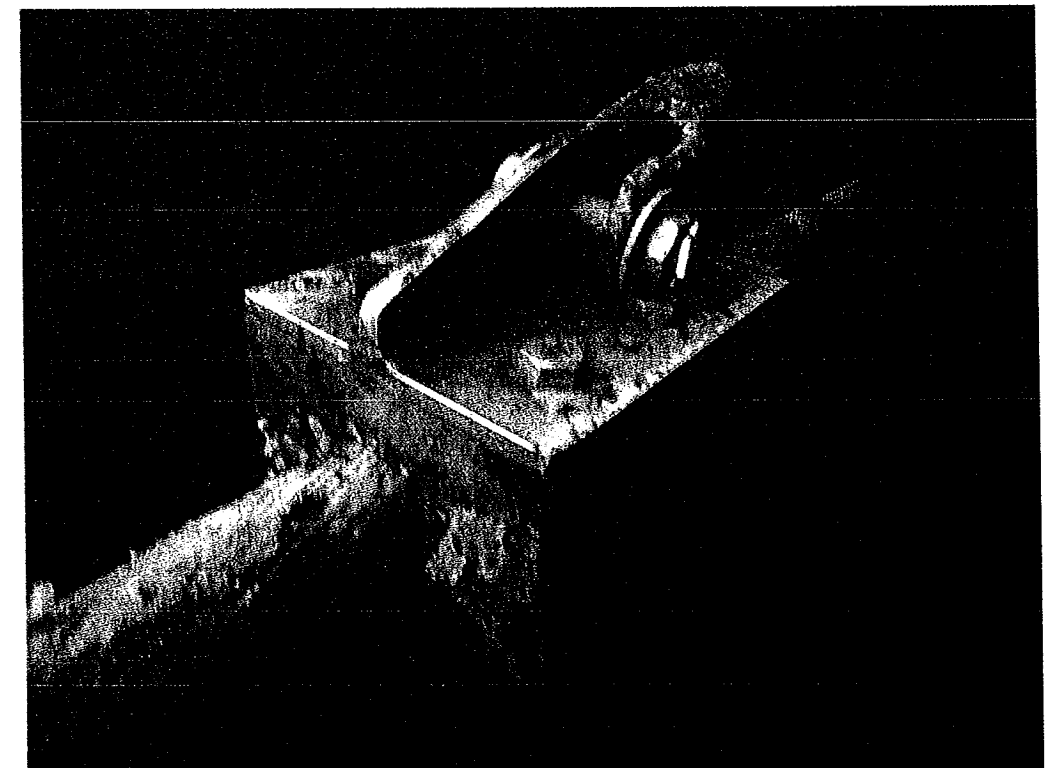
PHOTOGRAPH NO. 16: Cable J_N at -40 feet. View of the newly installed buoy clamp clevis pin shown missing in Photograph No. 15.

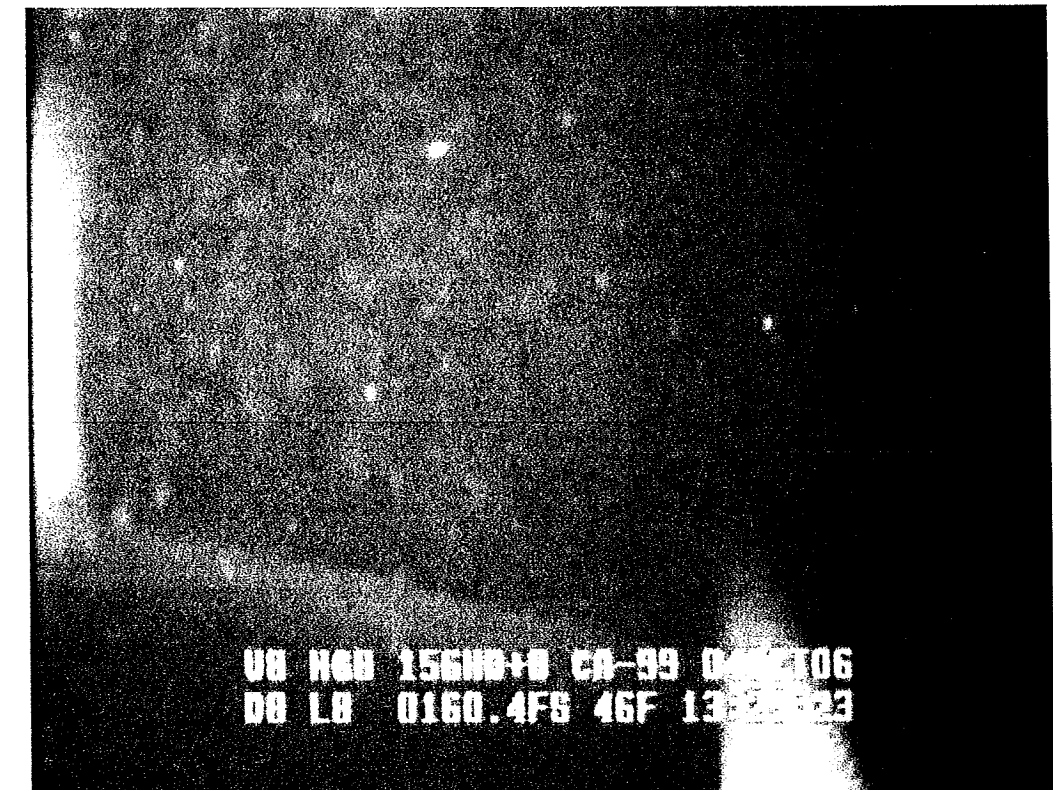
PHOTOGRAPH NO. 17: Cable Lls at -160 feet. View of active anchor cable resting on abandoned anchor cable of sunken pontoon.

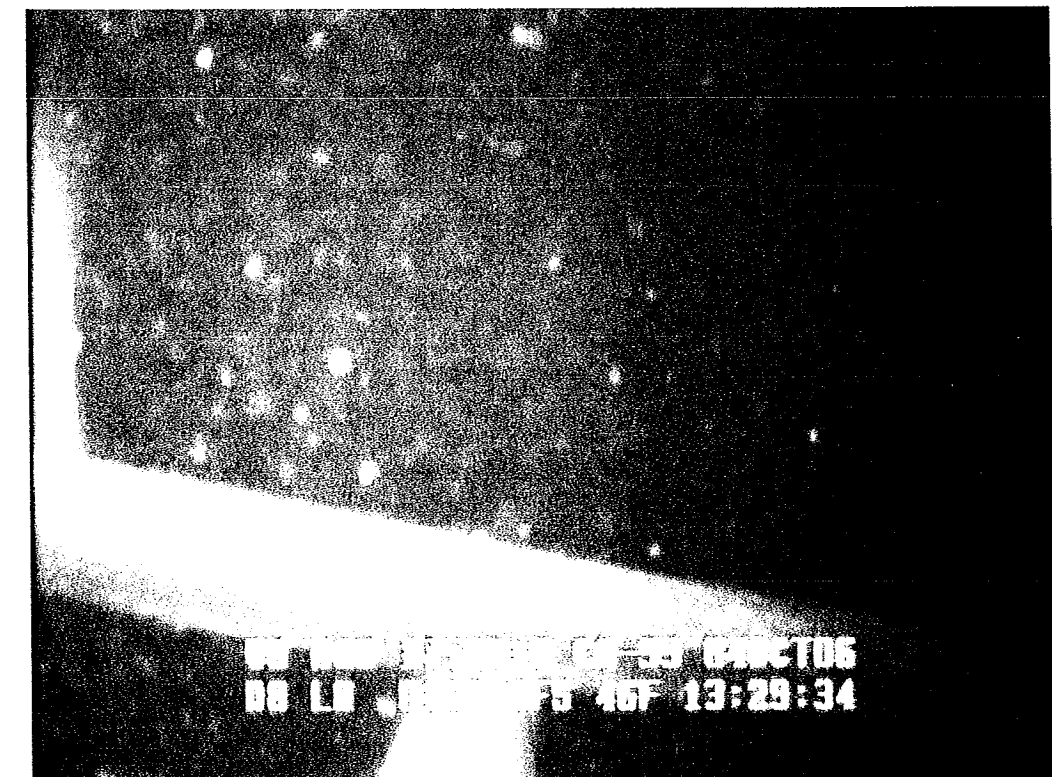
PHOTOGRAPH NO. 18: Cable Lls at -162 feet. View of anchor cable of sunken, abandoned pontoon resting on top of active anchor cable.

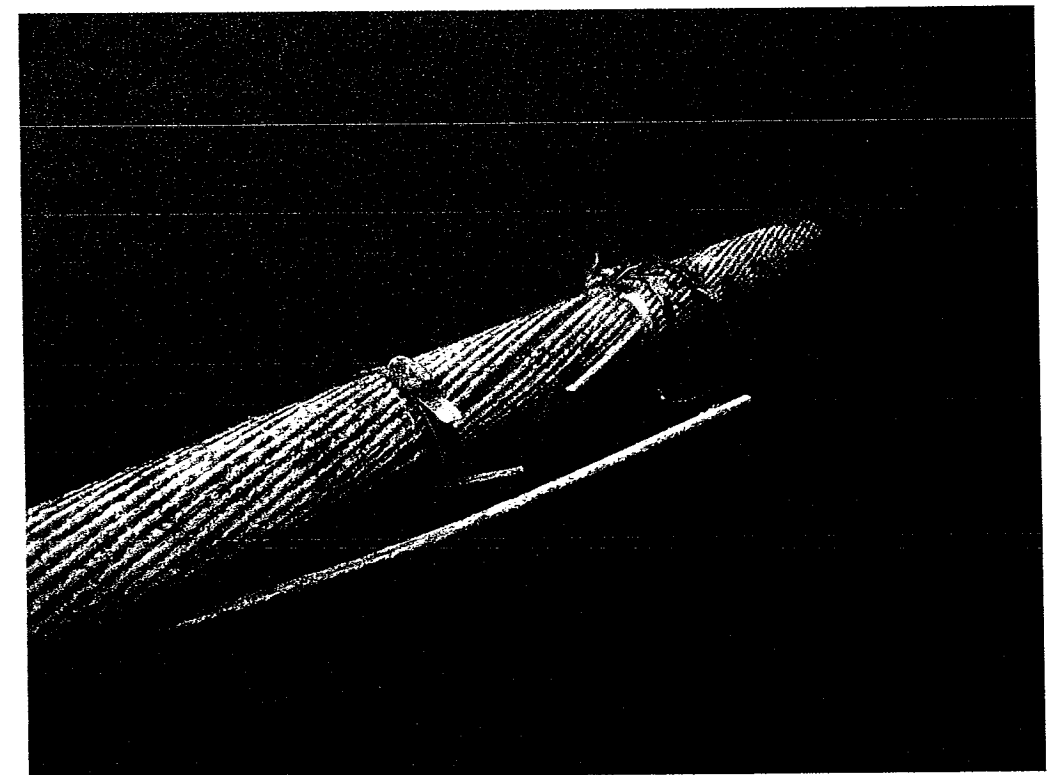
PHOTOGRAPH NO. 20: Cable M_N at -8 feet. View of failed seizing repair.

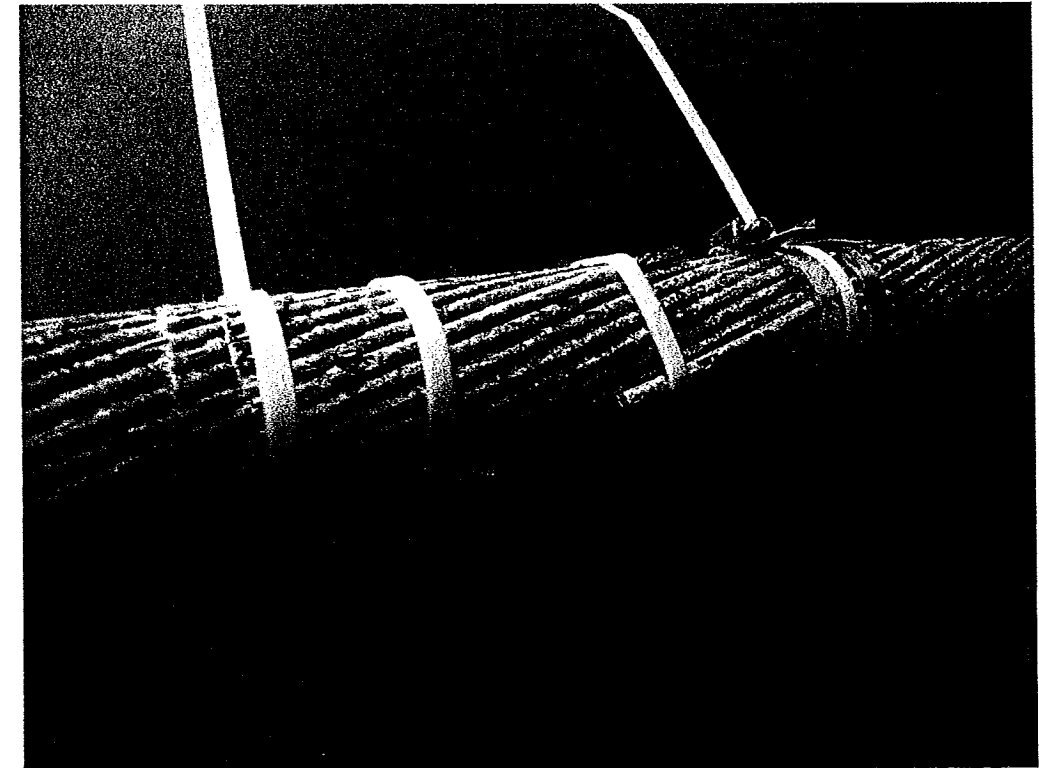
PHOTOGRAPH NO. 21: Cable M_N at -8 feet. View of new seizing repair applied to failed seizing repair shown in Photograph No. 20.

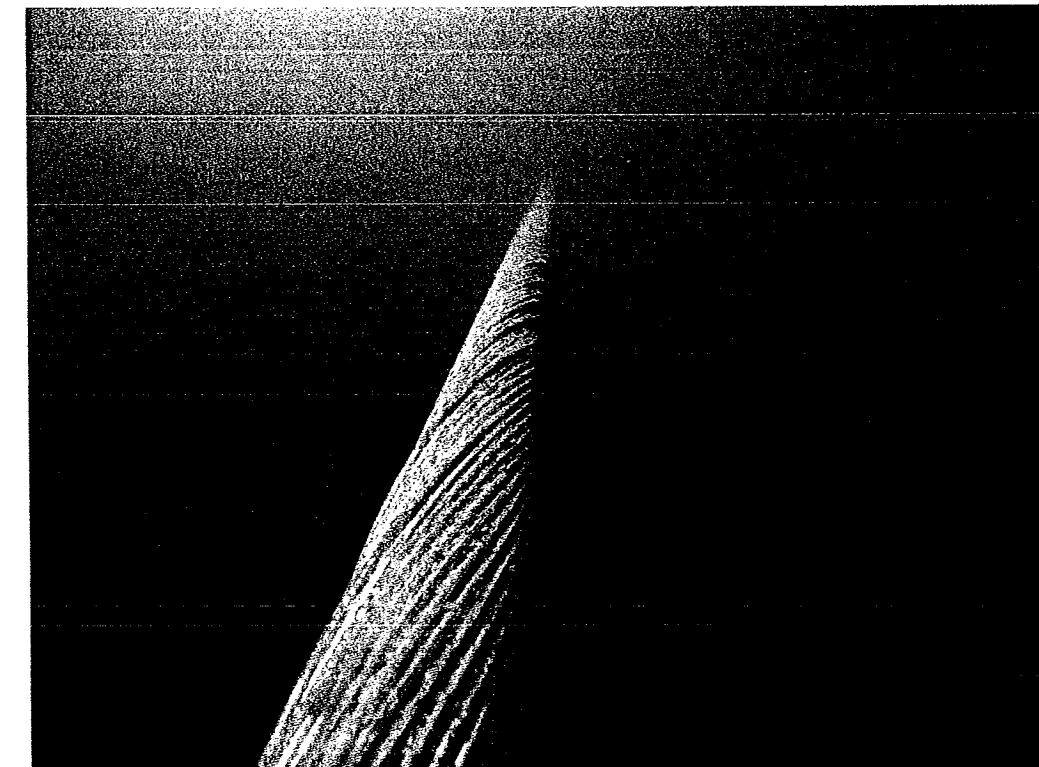
PHOTOGRAPH NO. 22: Cable N_N at -20 feet. Typical view of wires out-of-lay up to $\frac{3}{4}$ wire diameters.

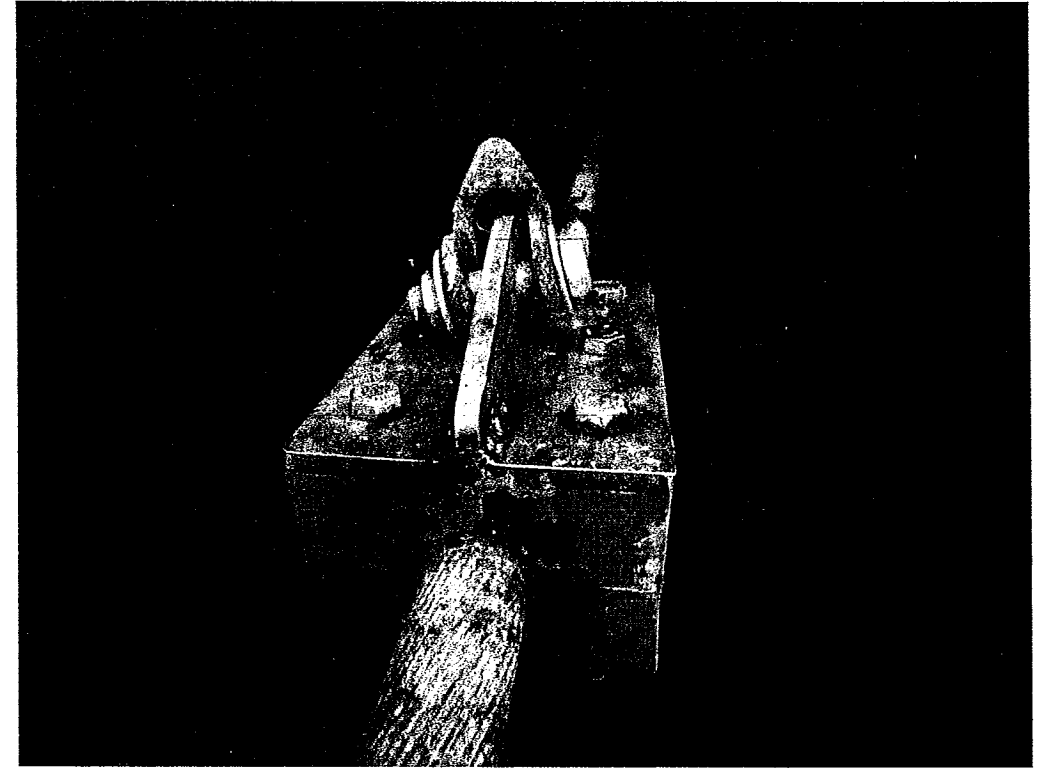
PHOTOGRAPH NO. 23: Cable Nn at -25 feet. View of the newly installed buoy clamp clevis pin. Original pin had failed.

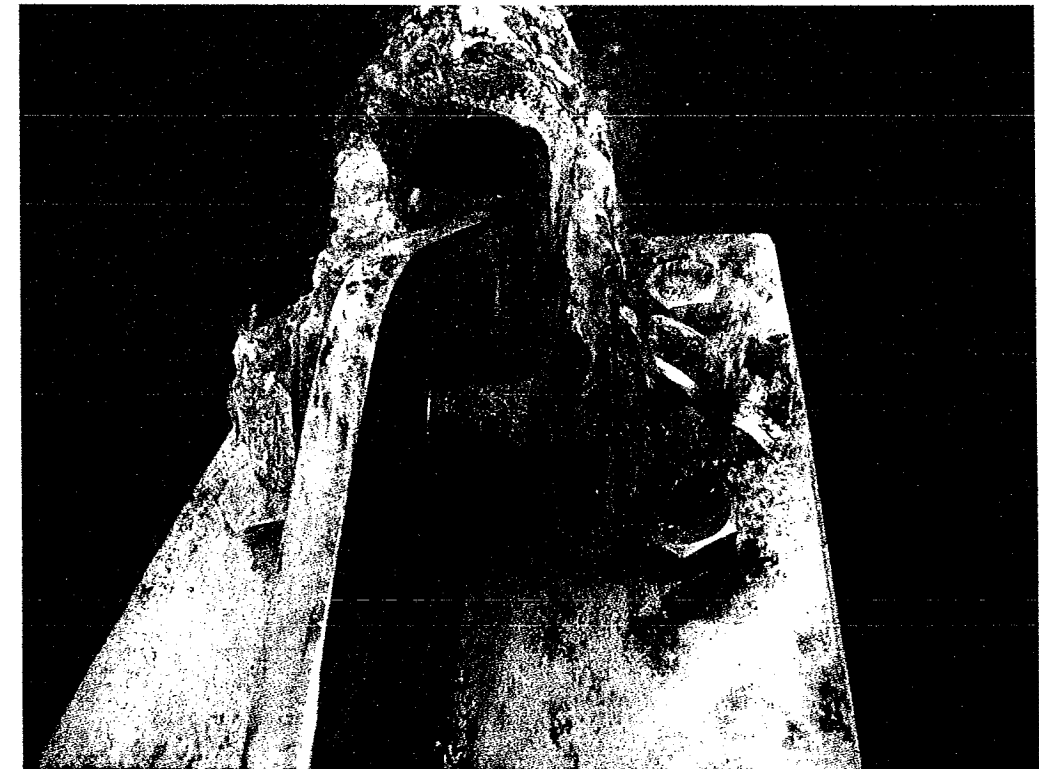
PHOTOGRAPH NO. 24: Cable On at -22 feet. Typical view of the buoy clamp clevis pin with 30% to 40% section loss due to wear.

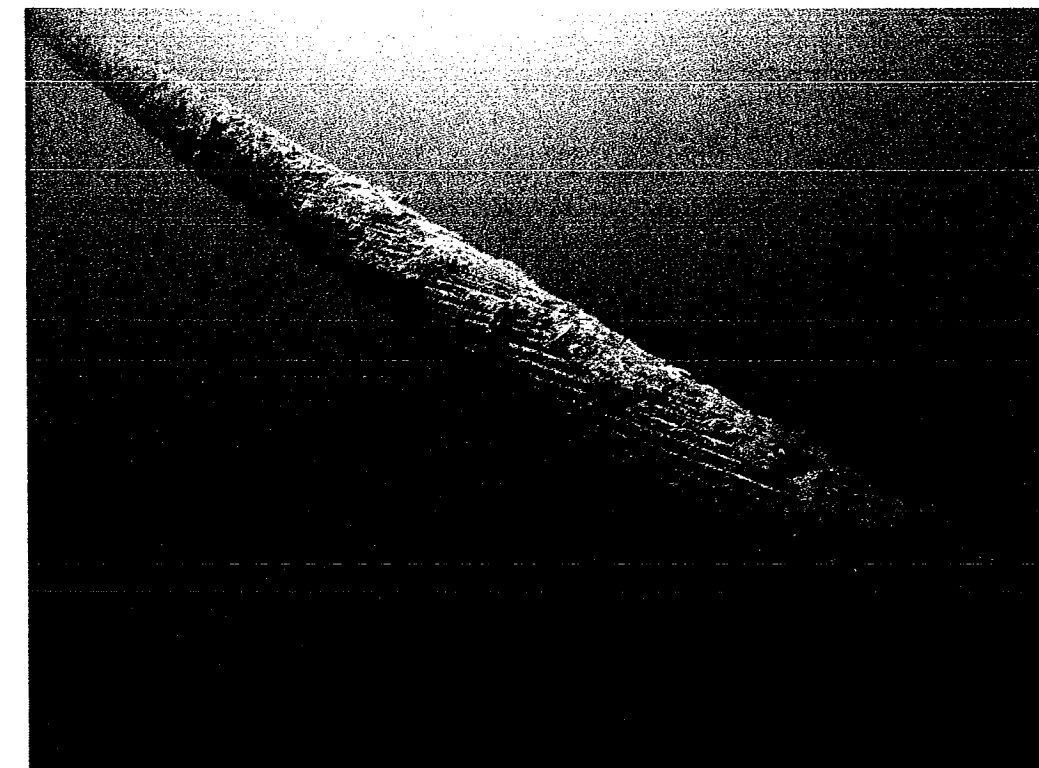
PHOTOGRAPH NO. 26: Cable QN from pontoon port to -10 feet. Typical view of light to moderate corrosion.

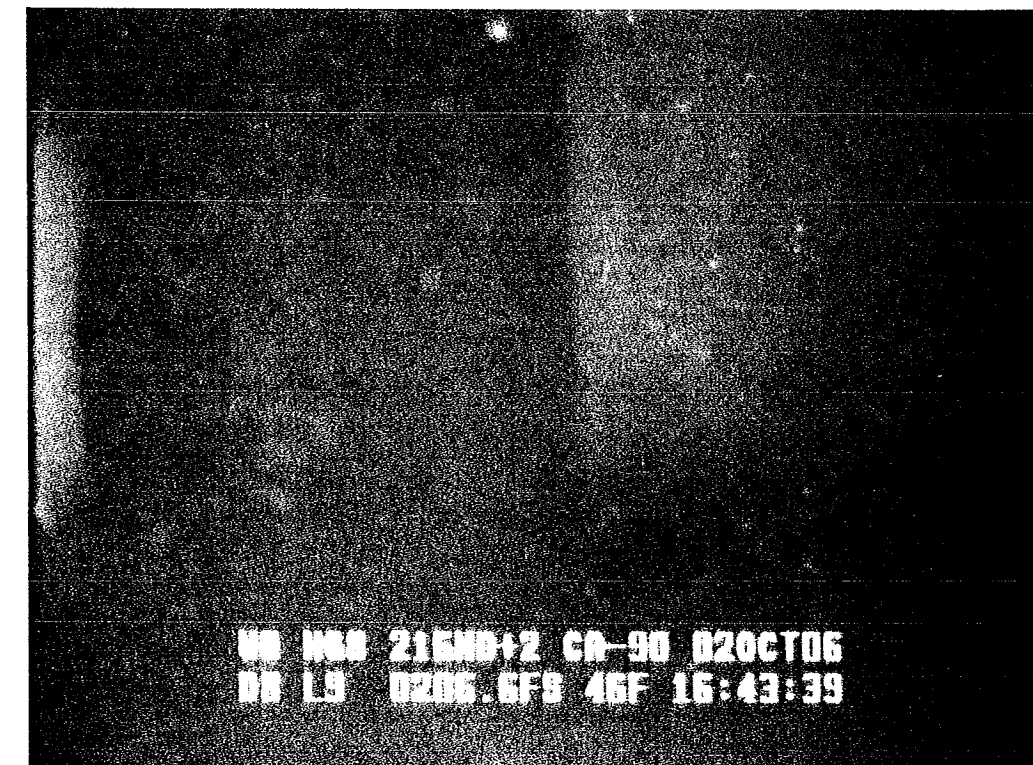
PHOTOGRAPH NO. 30: Cable G_N at the west corner of Type "A" Fluke
Anchor. View of west corner of the fluke.

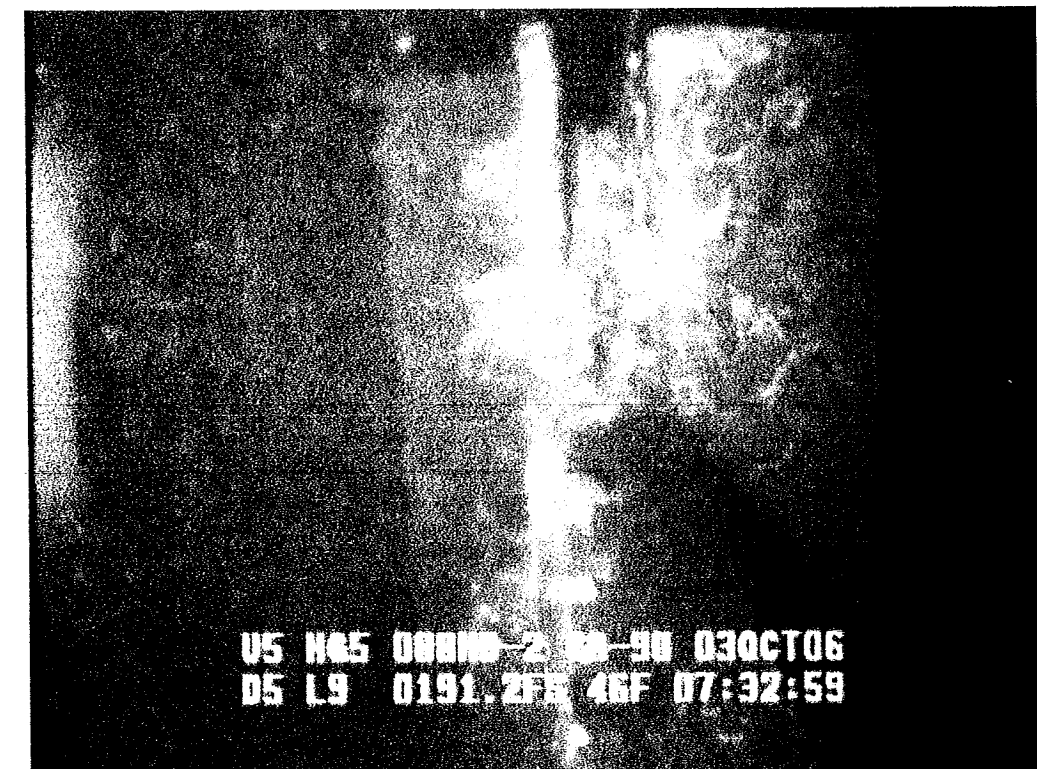
PHOTOGRAPH NO. 31: Cable IN at eyebar connection. View of connection between eyebar sections at -191 feet. Condition is typical for eyebars of Type "C" Box Anchors inspected.

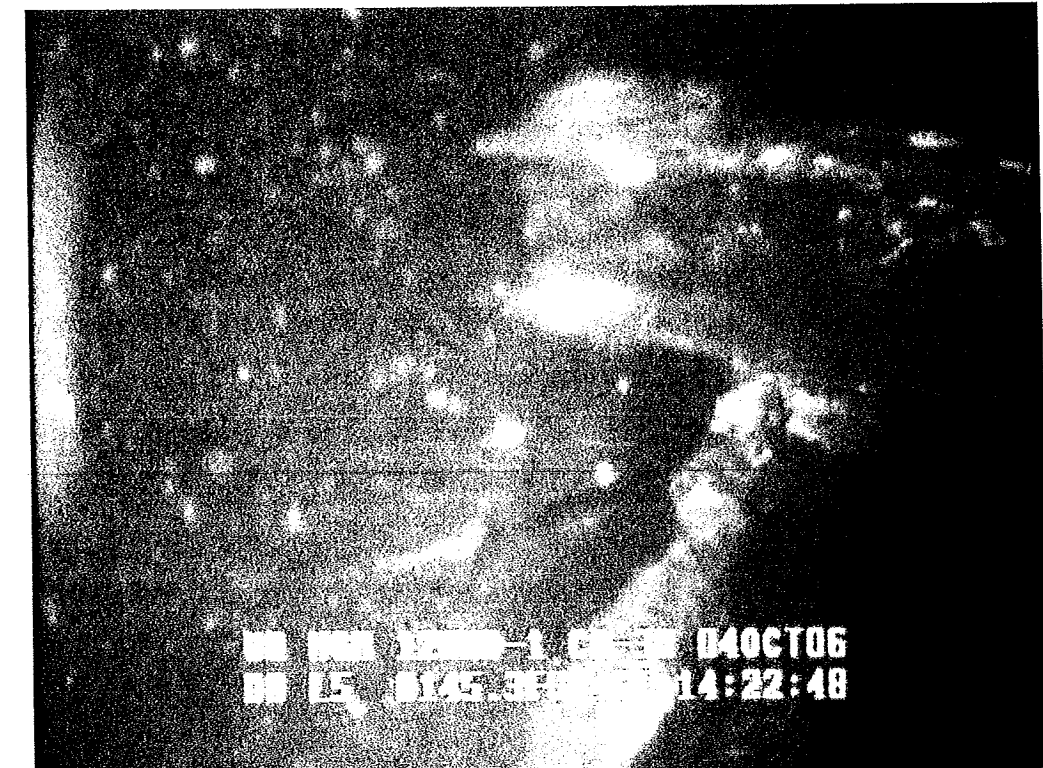
PHOTOGRAPH NO. 33: Cable L5s at pontoon connection. View of east pontoon connection at -145 feet.

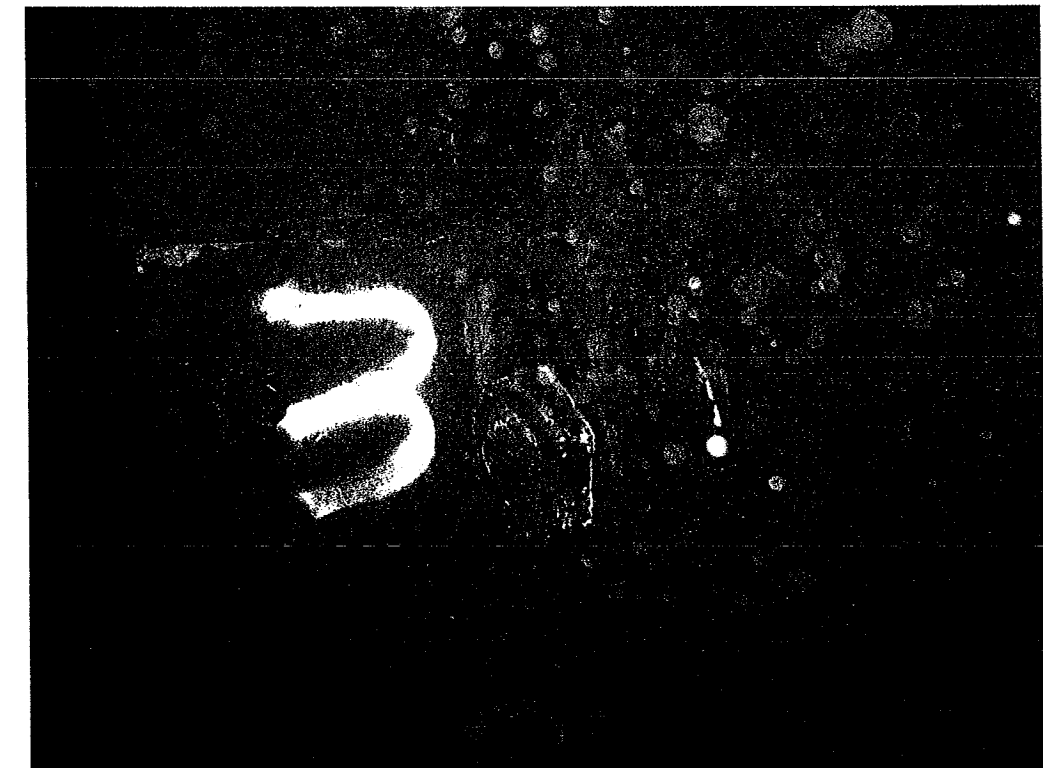
PHOTOGRAPH NO. 38: Cable Os at second pile. View of eyebar connection at -61 feet. Conditions of eyebar connection are typical for all Type "B" Pile Anchors inspected.

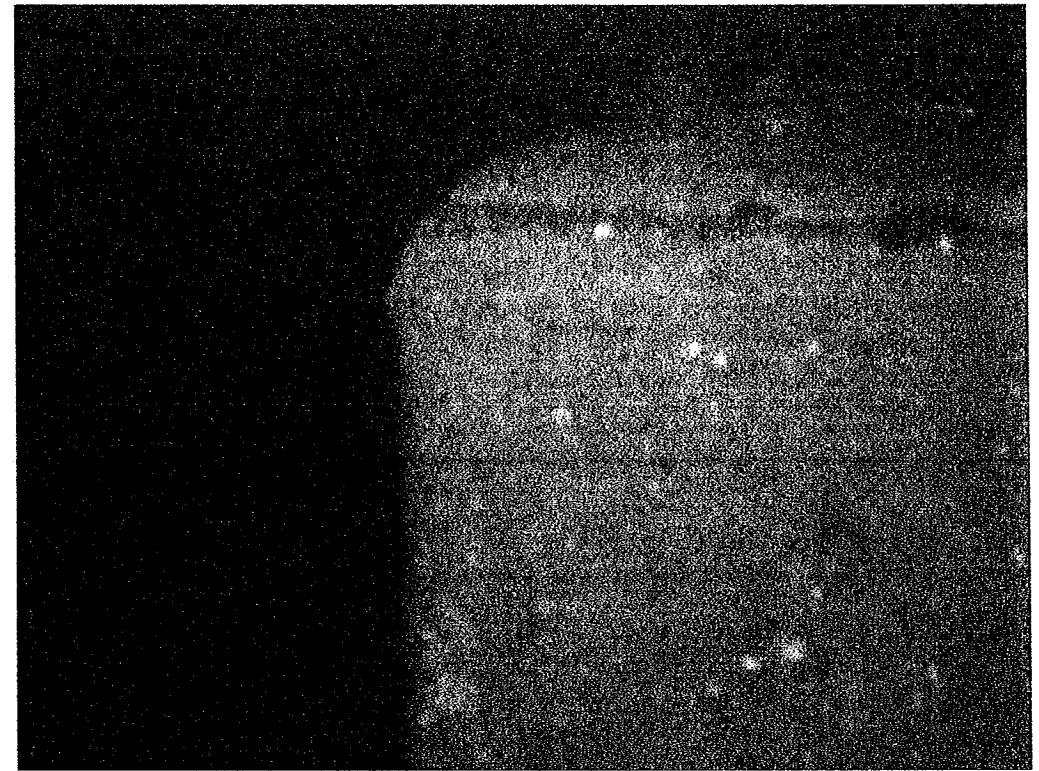
PHOTOGRAPH NO. 39: Cable Qs at southeast corner of Type "A" Fluke Anchor. View of the exposed southeast corner of fluke.
